Archeological Research Series Architectural Studies Number 4

Prelude to Tapestries in Stone: Understanding Cliff Palace Architecture

Larry V. Nordby

2001

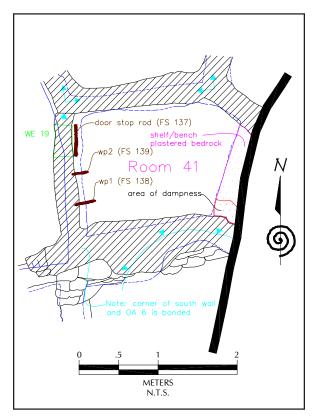
Figure 5.5. Plan View of Room 41.

Room 41 is in pristine condition, with all plaster unmodified. If anyone stayed in the room during the modern era, they left no evidence.

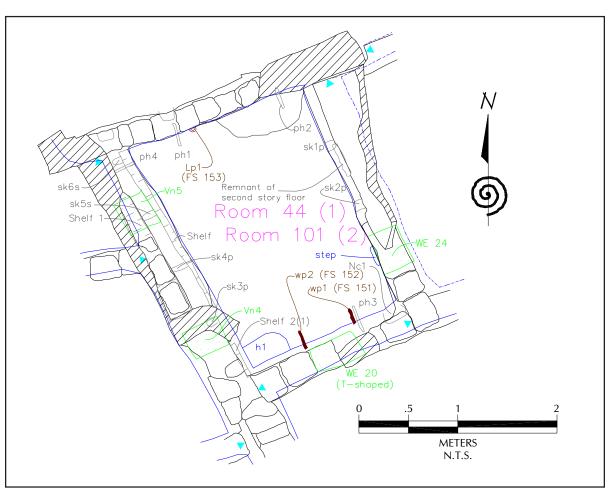
Figure 5.8. Plan View of Rooms 44(1) and 101(2).

Room 101(2) (Figure 5.8) is a second story attic-like room atop Room 44(1). Fewkes did not excavate nor did he notice the row of secondary roof supports in the east and west walls of Room 101(2). There is no record of preservation work in this room other than what might have been done along with the north wall repairs, when Fewkes may have repaired the primary socket in the north wall of Room 44(1).

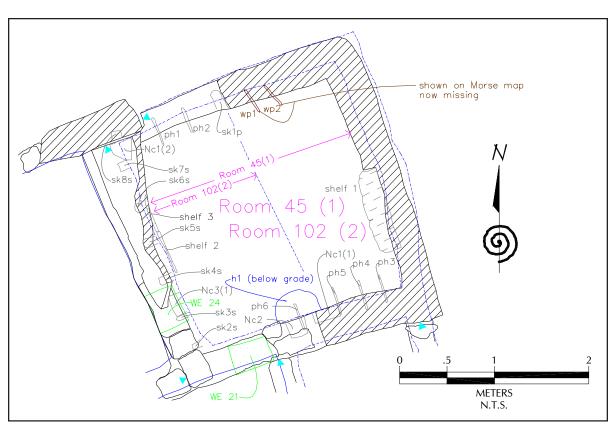
Figure 5.9. Plan View of Rooms 45(1) and 102(2).

Since no stabilization has been done in Room 45(1), each wall consists of a single sector of original masonry. All are of single-stone masonry, although in some cases, thick blocks were placed on edge. The north and east

walls retain small areas of plaster in locations that indicate a monochrome was once applied. Numerous sub-features are present.

Room 102(2) (Figure 5.9) is the second story room above Room 45(1). It was not excavated. Generally, neither Fewkes nor Nordenskiold numbered second story units separately, even if they had recognized that Room 45(1) did have a second story. There is no record of any preservation treatment in Room 102(2), even though Jack Smith's notes of the early 1980s outlined areas damaged by seepage from the alcove. The moisture damage to the north wall that he chronicles never was repaired.

Very little remains of the walls of Room 102(2). A pair of upright slabs is all that is left of the north wall. The southern wall has fallen, although the finished end of the abutting wall of Room 46 shows that it extended to the alcove wall. The west wall consists of two large upright slabs, with Room 101(2) on the other side of the slabs. It is likely that the southern part of the west wall would have been left open, as well as the portion of the wall above Wall Entry 21, because it would have supplied an access point and allowed smoke from the hearth in Room 45(1) to escape.

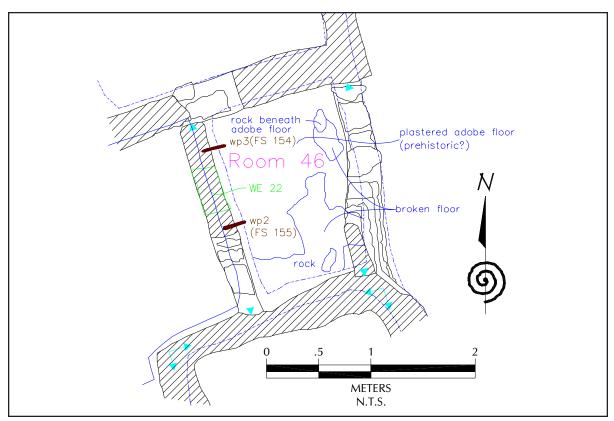
Figure 5.10. Plan View of Room 46.

Room 46 (Figure 5.10) was numbered by Nordenskiold (1893: facing page 60) as Room 38. This unit was excavated by Fewkes (1911). Apparently, it was too mundane to provoke any interest, failing to elicit even a single line of verbiage. Chandler (1989: 48) attributes some preservation activity at the south end of the east wall to Fewkes, based upon her interpretation of the Morse map. From our field inspection, it does not appear that Fewkes did any stabilization work on Room 46.

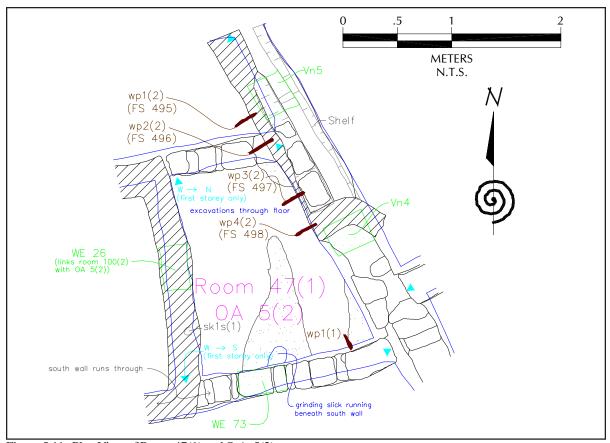
Figure 5.11. Plan View of Room 47(1) and O.A. 5(2).

The south wall in Room 47(1) has been stabilized, probably by Fewkes, but the quality of the work is such that without better documentation, it is not possible to

be certain. There is no evidence that any work was done on the east wall of the room, which retains the original plaster. The upper portion of the north wall was repointed during the modern era, probably by Fewkes. In addition, a stack of stonework added to the exterior of Room 100(2) was probably added by Fewkes. This modern addition runs contrary to the interpretation of the second story space made in this report. The basal portion of the west wall has been repointed, resulting in a plaster that simply derives from mortar joint extrusions.

Open Area 5(2) (Figure 5.11) is located above Room 47(1). It was never investigated by anyone previously. Although it can easily be misconstrued as an enclosed space, it probably never was enclosed and the stack of masonry on the north wall is actually a modern addition done by Fewkes' crews.
